THE OKOMU OIL PALM COMPANY PLC

ENVIRONMENTAL AUDIT REPORT FOR SOLID WASTE DUMPSITE

Environmental Audit Report of Okomu Oil Palm Company Plc (Solid Waste Dumpsite) at Ovia Southwest Local Government Area, Edo State, Nigeria

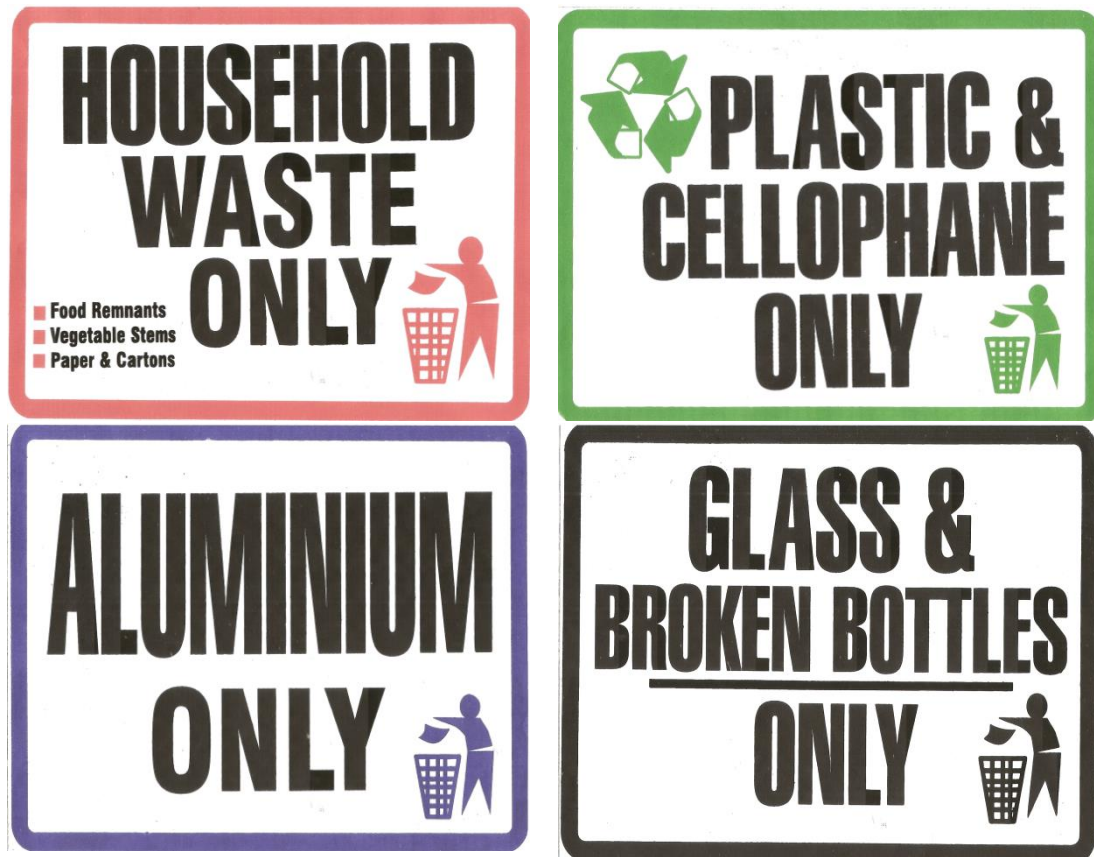
Plate 1: Colour Codes for Different Solid Waste Generated on the Estate

At all the points of waste generation, waste bins are provided for the immediate storage of solid waste. Provision is also made for sorting and segregation of all solid waste at the point of generation (see Plate 2).

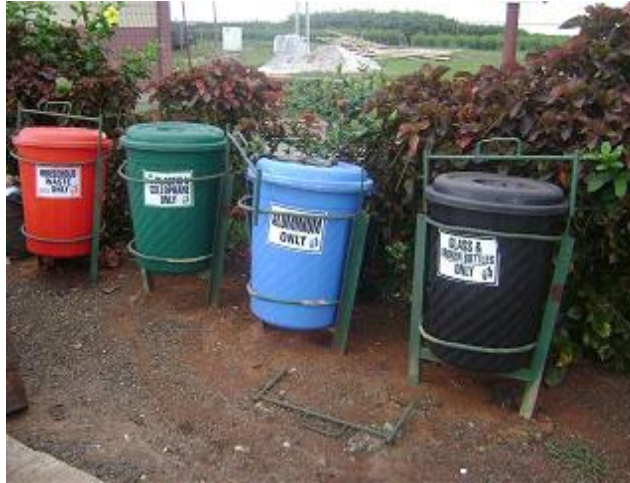
Plate 2: Solid Waste Storage System

Sorting of waste from source is being done as shown in Plate 2.

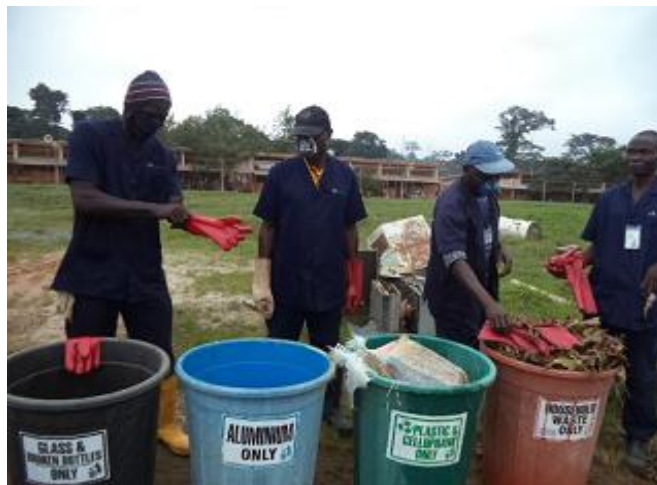
Plate 3: Waste Collection in Progress

Adequate Personal Protective Equipment for waste management staff always (see Plate 3).

Necessary precautions are taken on the handling of wastes. All workers involved in the handling of waste (waste managers) are kitted with appropriate personal protective equipment. The PPE provided include protective clothing, hand gloves, eye goggles, caps, respirators, and boots as depicted in Plate 3.

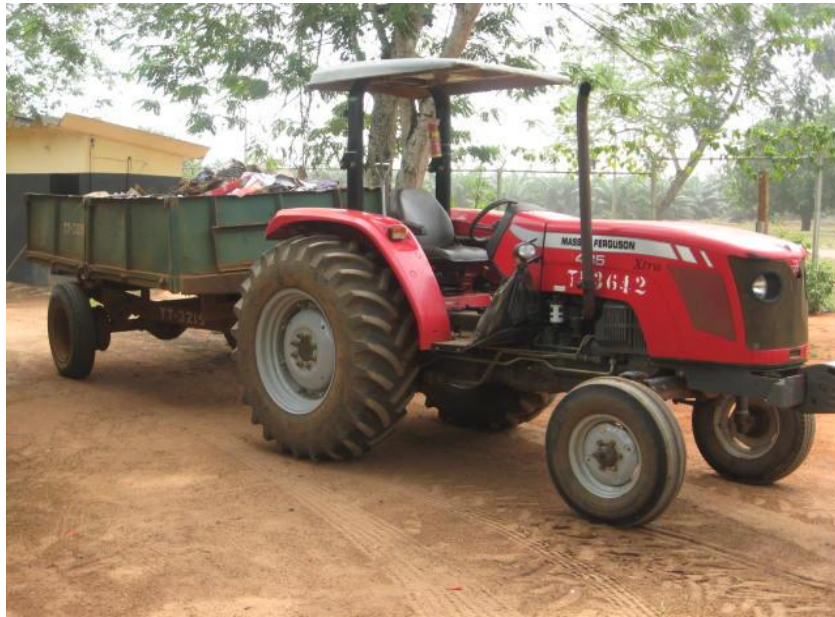
Plate 4: Tractor-Mounted Bucket

Waste collection and transfer include the provision of a tractor-mounted bucket to collect and transport the collected waste to a designated solid waste dumpsite (see Plate 4).

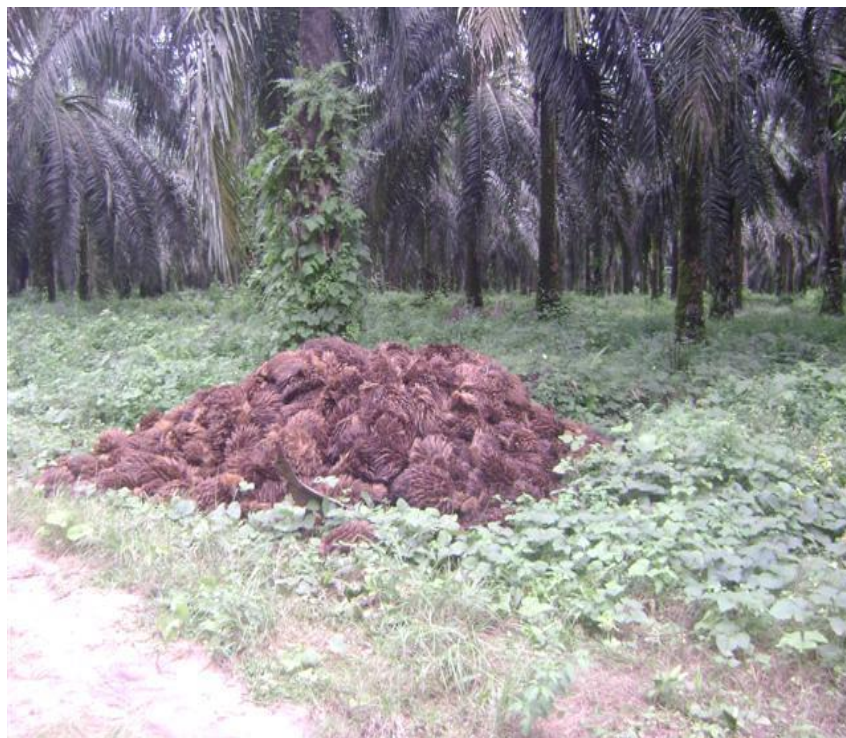
Plate 5: Empty Fruit Bunches (EFB)

Empty Fruit Bunches and boiler ash are recycled in the field to produce manure for the palm (see Plate 5).

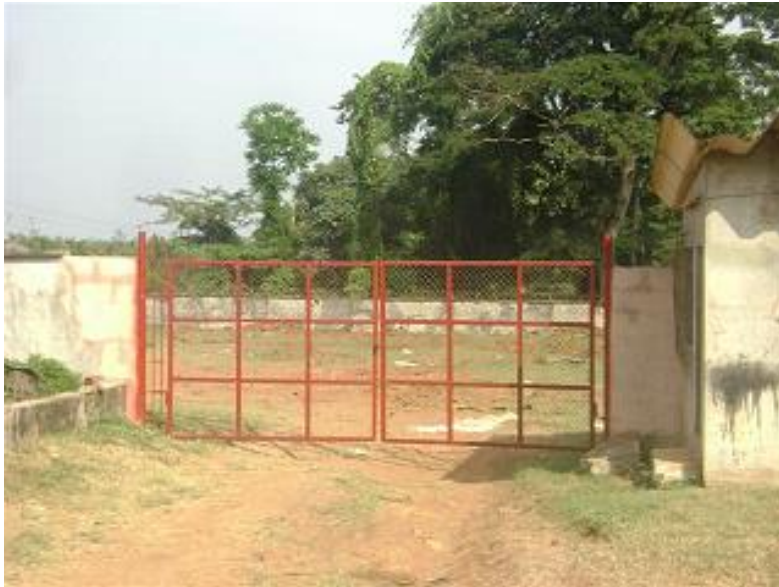
Plate 6: Scrap Yard Always Under Lock

The solid waste dumpsite is the final/disposal point for all solid waste. It is in a remote area within the plantation and has enough capacity of 200m x 100m (approximately 15 hectares) to receive the domestic waste generated on the estate. The solid waste dumpsite is primarily for domestic (organic) waste while the inorganic waste is either sold or collected by the suppliers.

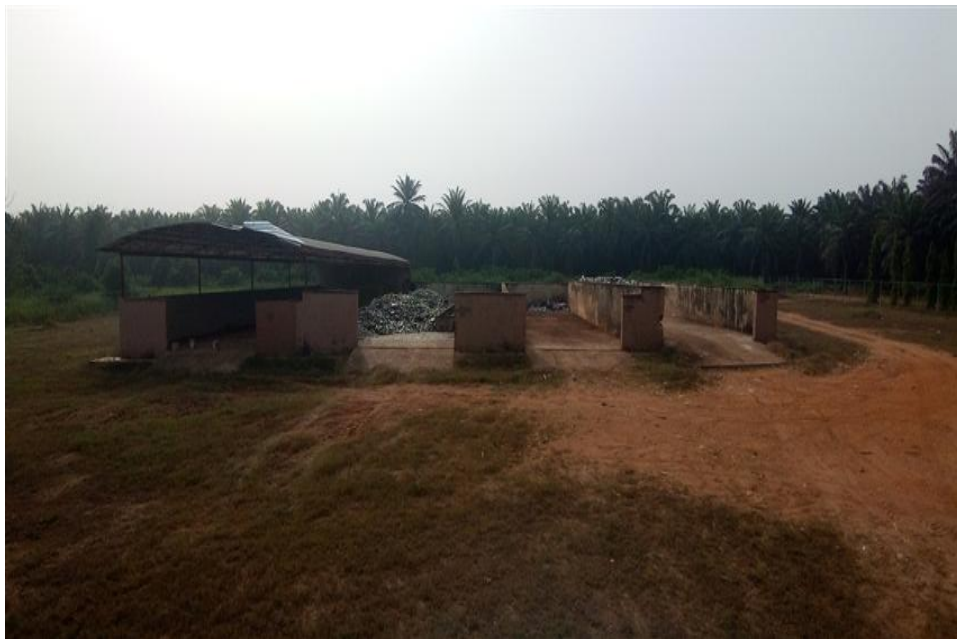
Plate 7: Good Housekeeping at Solid Waste Dumpsite Facility

Housekeeping is generally good at and around the solid waste dumpsite including the nearest residential quarters as depicted in the photograph below.

The method of storage and evacuation seems to conform to the 5 S's principle namely, sorting, straightening, sweeping, standardizing, and sustaining the discipline. This has yielded good results thus culminating into proper and appropriate waste collection by potential waste recyclers.

Housekeeping and sanitation at solid waste dumpsite are fair but can still be improved upon especially at the excavated part of the SWD for decomposable waste. It is recommended to:

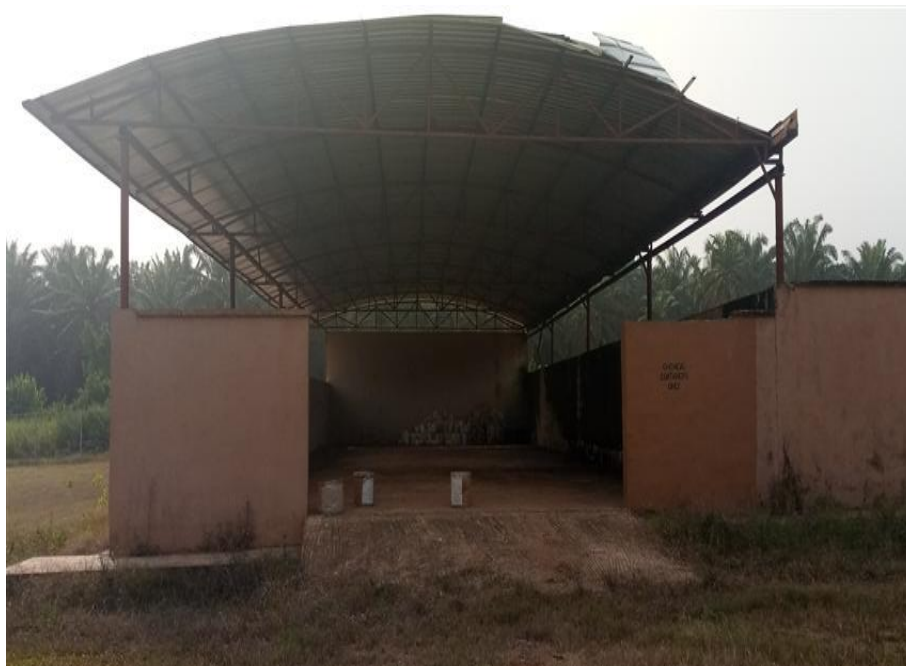
Plastic and metal pesticides containers are properly rinsed before they are taken to the dumpsite for transitional storage. The company has not experienced any stock of outdated pesticides.

Plate 8: Empty Agrochemical Containers' Storage Compartment covered with roofing sheet to prevent run-off during rainfall

- ✓ *Containment bunds with suitable capacities have been built for the waste storage compartment particularly for the empty agrochemical containers.*
- ✓ *Large quantity of suitable absorbent such as sawdust and sand in case of accidental spillage or leakage have been provided for empty agrochemical containers compartment.*

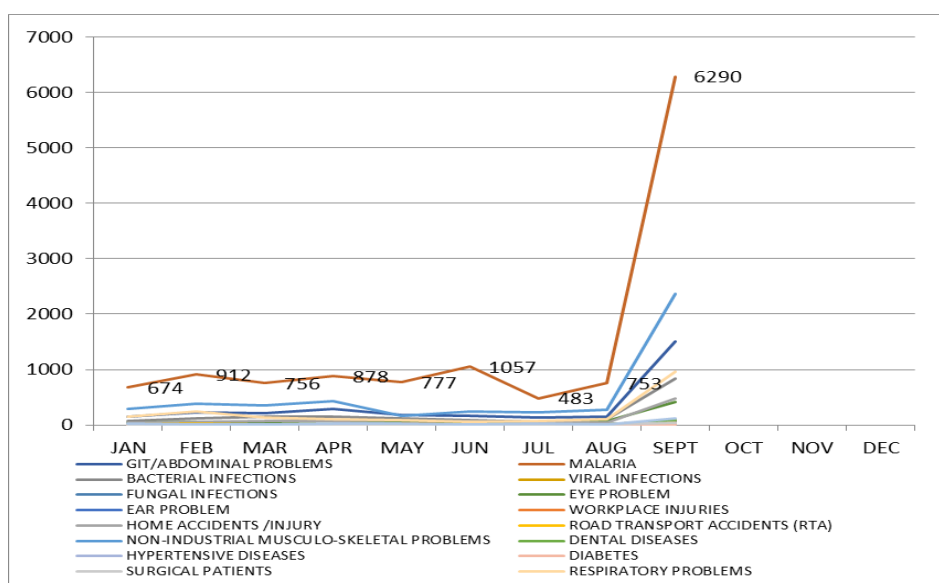
Figure 3.1: Analysis of Major Illnesses in 2020

Occupational Illnesses by Type: Of all the cases treated in 2020, malaria with appear to be the most prevalent illness with about 44.86%, followed by Non-Industrial Musculo-Skeletal problems with 16.86%, followed by Respiratory Tract Infection (RTI) with 16.84%, followed by GIT/Abdominal Problems with 10.74%, followed by Surgical Patients with 6.84%, followed by Bacterial Infections 5.97%, , followed by Skin Infections with 4.08%, followed by Home Accidents/Injury with 3.38%.

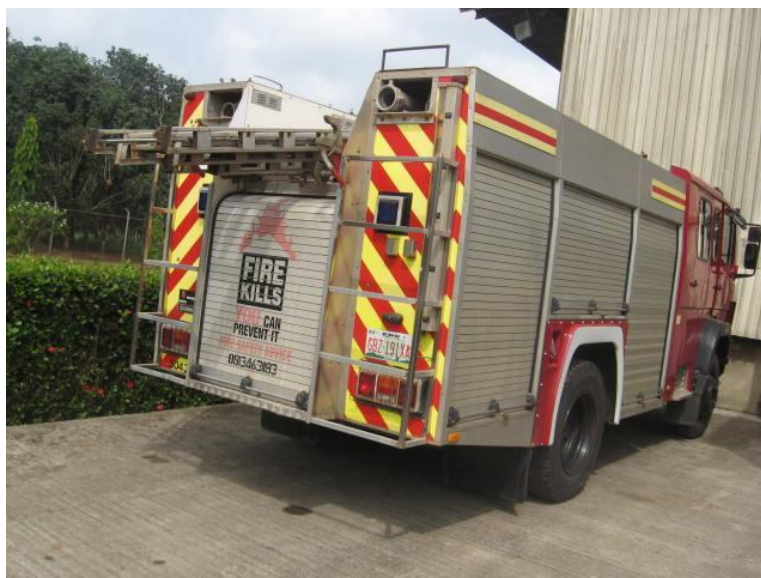
Plate 9: Stand-by Fire Fighting Truck at Rubber Factory

Provisions are made for firefighting equipment including fire truck, fire extinguishers, sand buckets, and stand-by water tankers in case of fire outbreak.

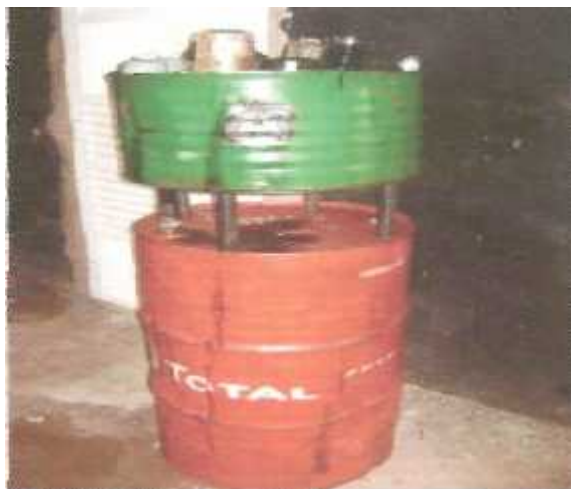
- Used oil filters (excess oil drained off before disposal). Collected by a government approved collector/organization.
