**ENVIRONMENTAL AUDIT REPORT OF THE RUBBER  
ESTATE INCLUDING RUBBER PLANTATION & RUBBER  
FACTORY AT OKOMU-UDO IN OVIA SOUTHWEST  
LOCAL GOVERNMENT AREA, EDO STATE, NIGERIA**

**FEBRUARY 2025**

# Environmental Audit Report of Okomu Oil Palm Company Plc (Rubber Estate including Rubber Plantation & Rubber Factory) at Okomu-udo in Ovia Southwest Local Government Area, Edo State, Nigeria

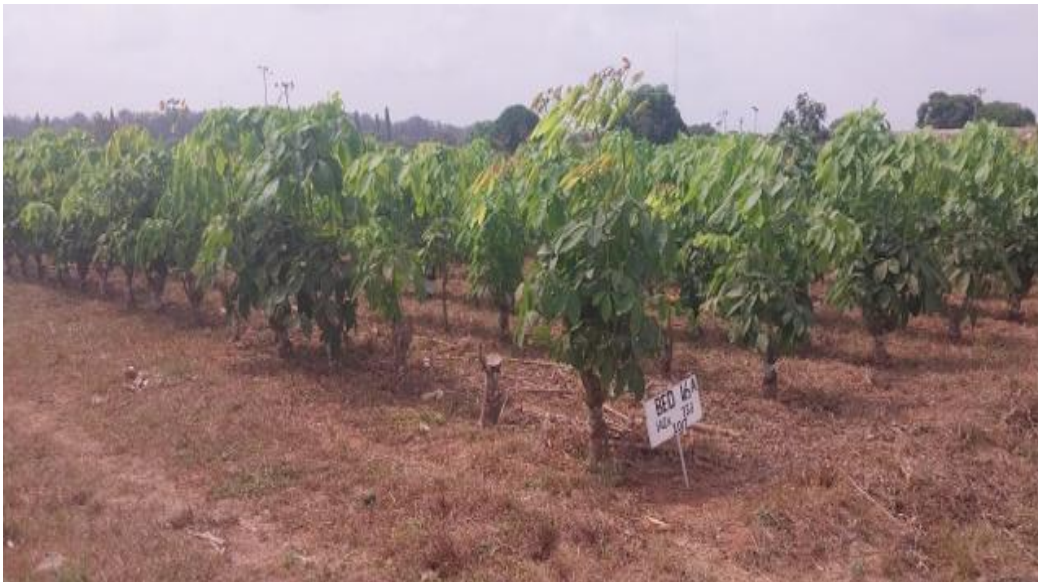
**Plate 2.1: Budwood Garden**

The bud-wood garden has a collection of different clones of rubber of different origins. The bud-wood garden is about 12.25 hectares.

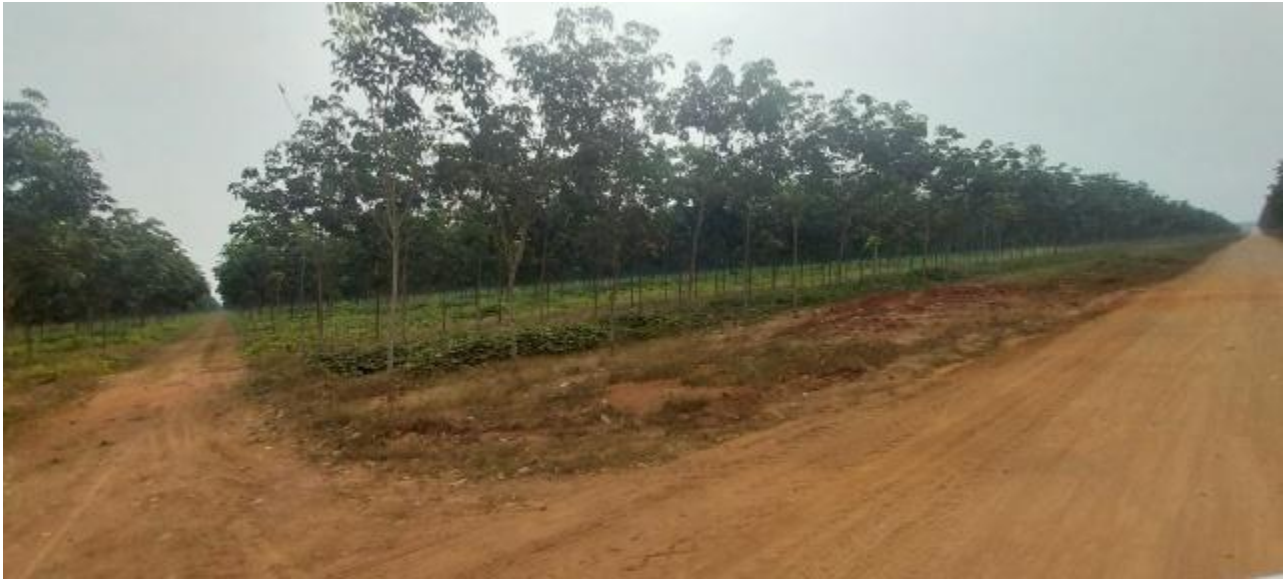
**Plate 2.2: Rubber Plantation/Field Layout**

The plantation is laid out in double and single line spacing. The planting rows are aligned North-South to allow for optimum light interception. The IRCA230 and PB314 rubber clones were solely planted initially, while the GT1 PB312, PB217, RRIC100 and RRIM703 dominated the latter plantings.

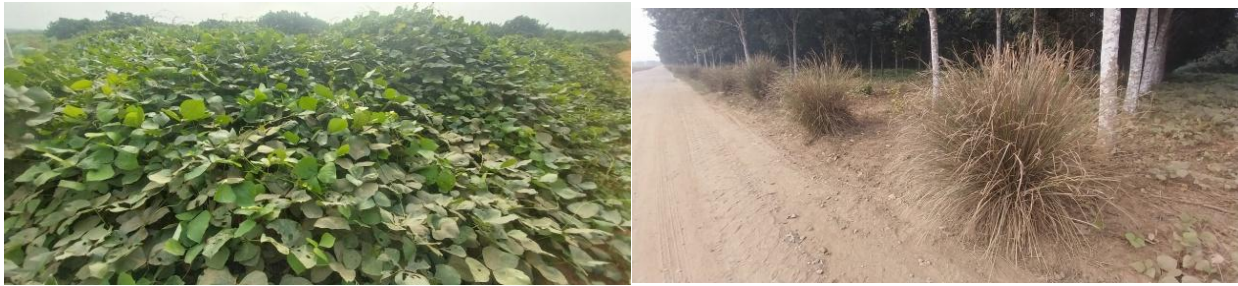
**Plate 2.3: Cover Crop and Vetiver Plants for Soil Conservation**

In addition, the leguminous cover crop, Pueraria is planted to provide ground cover and supply Nitrogen to the soil. In some cases, Vetiver (*Chrysopogon zizanioides*) is planted for soil erosion control, soil moisture retention, weed suppression and soil health improvement.

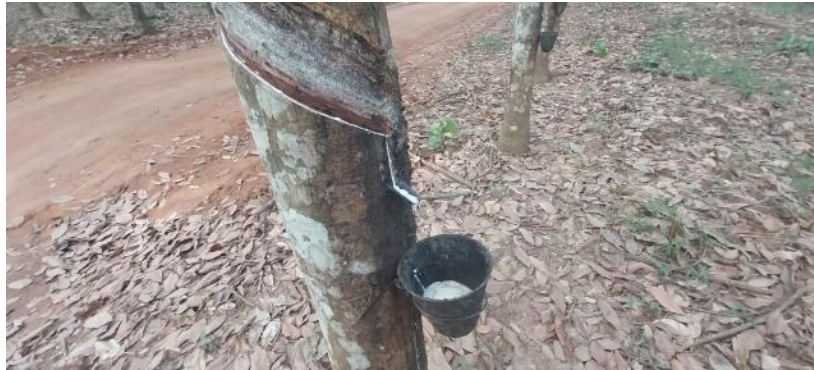
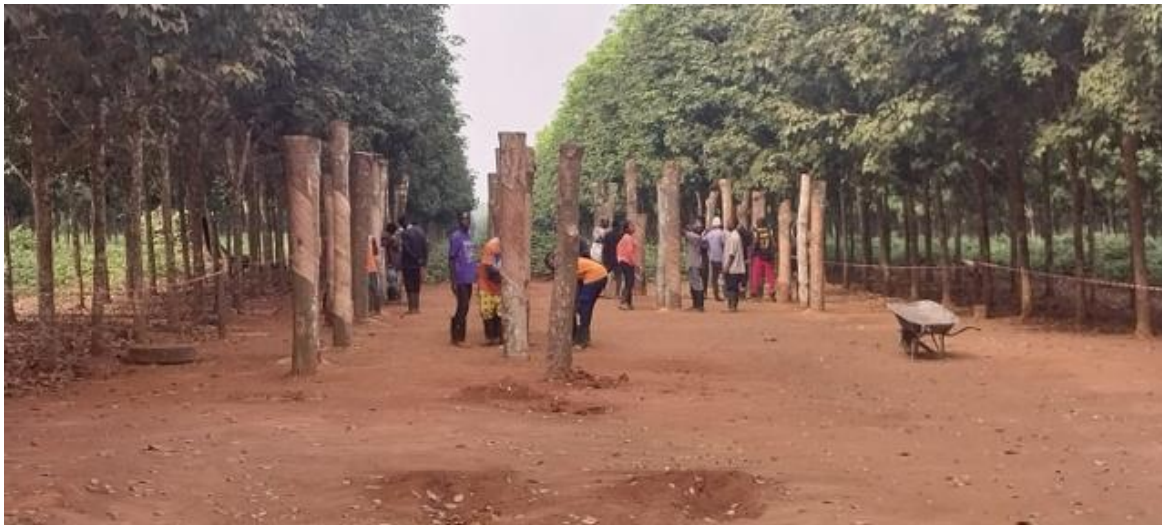
**Plate 2.4: Collection of Rubber Latex and Tapping School**

Tapping knife is used in tapping the mature rubber trees. The coagulated latex (cup lumps) is collected and transported to the cup lump shed inside the factory in trucks.

There is also a tapping school where plantation workers are taught tapping techniques to ensure rubber trees are effectively tapped.

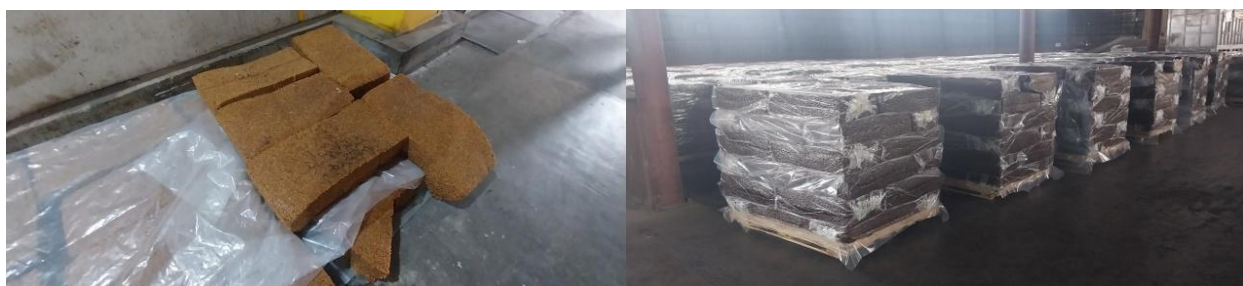
**Plate 2.6: Rubber Bales**

Natural Rubber is a renewable raw material with many advantages and a significant carbon sink, is used in production of many domestic and medical objects such as tires (automobiles and aircraft tires), airbags, clothing, erasers, adhesives, rubber gloves, gym and commercial kitchen flooring etc. The Company usually produces TSNR 10 type products, and the rubber is marketed under the highly sought after NOKO10 label and sold worldwide to internationally renowned companies such as Michelin, Goodyear, and the like, thereby generating vital foreign exchange for the country.

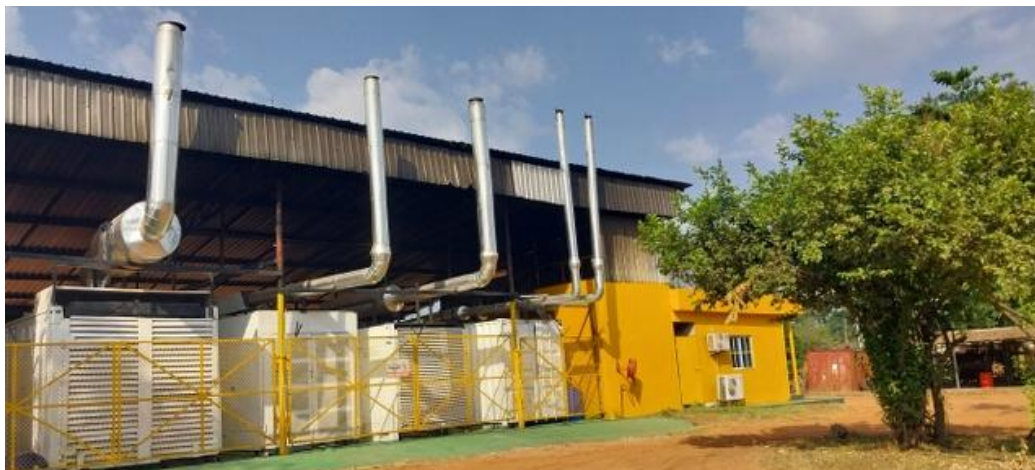
The power generation facility is well maintained and the electricity generated from the powerhouse is supplied to the rubber factory, offices and residences.

**Plate 2.7: Generating sets at the Main Estate Powerhouse**

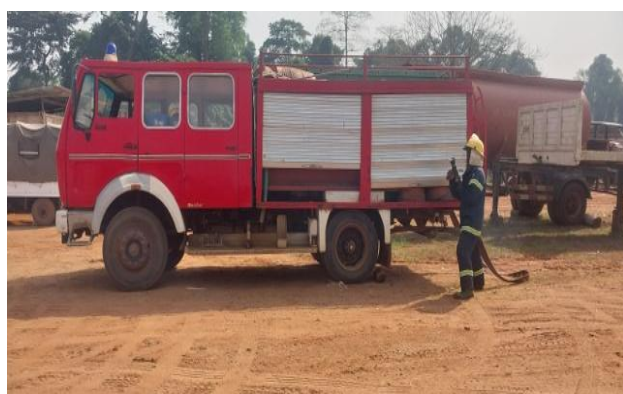
**Plate 2.7a: Fire Fighting Truck at Main Estate**

There is a fire station equipped to provide fire prevention and control services. The station is strategically located, adjacent to the filling station and proximal to the administration office. During dry season, water bowser is attached to some vehicle as an emergency preparedness in event of fire within the estate and plantation.

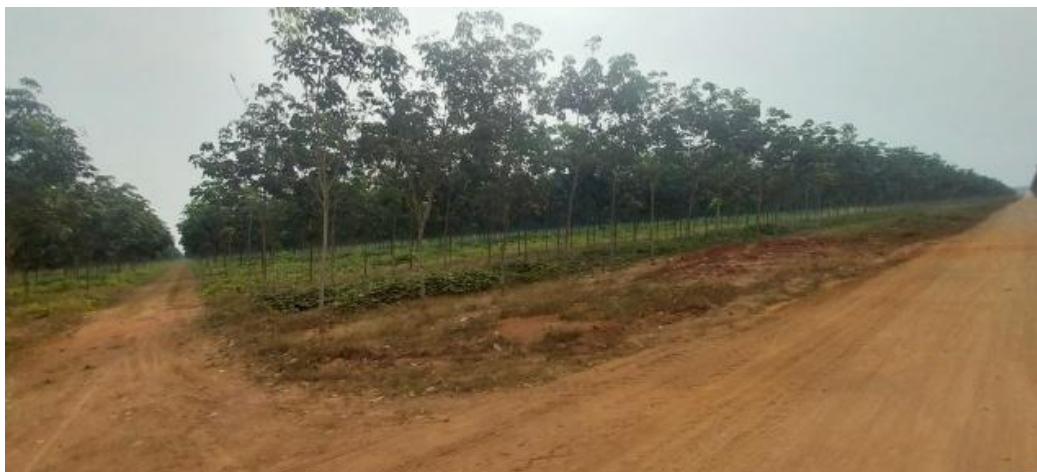
**Plate 2.8: Road Network at Rubber Estate**

There is a network of earth roads of about 326.7 km connecting all workplaces and facilities at the main estate.

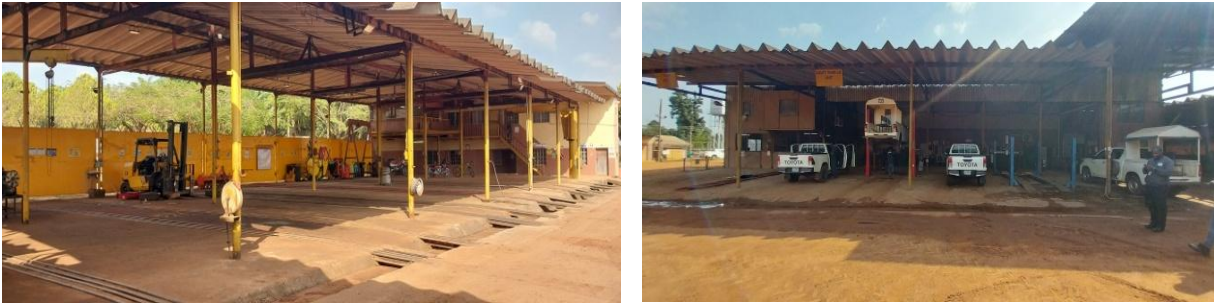
**Plate 2.9: Picture Showing the Facility Workshop**

There is a main workshop comprising different functional units or sections including Lathe Machine, Light vehicle, Tractor, Electrical, Changan, Lorry, Vulcanizer, Mechanical and Welding sections. These units undertake mechanical works, civil repairs, and maintenance works. The workshop is equipped with lifting and hoisting equipment of different capacities between 1.5-5tons.

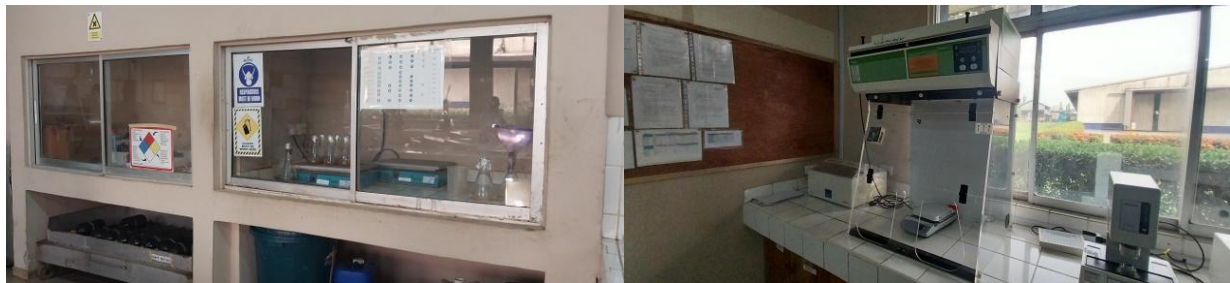
**Plate 2.10: Static and Mobile Fume Cupboard**

The rubber laboratory undertakes dirt content analysis, in addition to process and product quality monitoring. It is fitted with equipment including ovens, Wallace rapid plastimeter, roll mill, mooney viscometer, ageing chamber, fume cupboard, scales and balances, and other quality control equipment for process efficiency and quality monitoring. The laboratory is an attachment to the rubber factory administration office located opposite the warehouse loading bay.

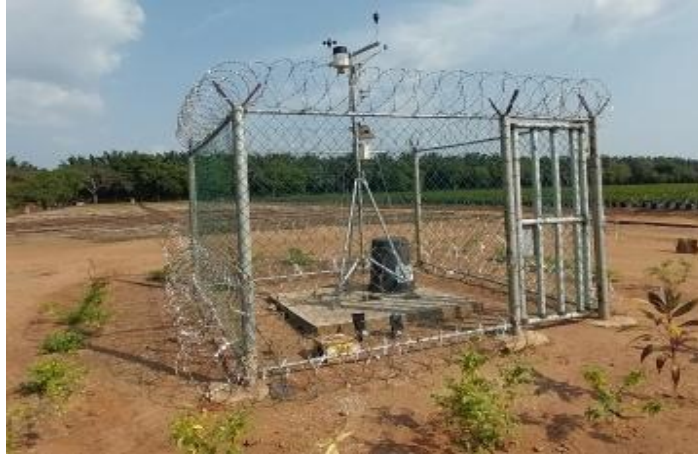
**Plate 2.11: Typical Weather Station on the Estate**

There is one (1Nos.) weather station located at the rubber estate. The weather station is equipped with rain gauge, thermometers and piche-evaporimeter to collect data on rainfall, temperatures, and sunshine.

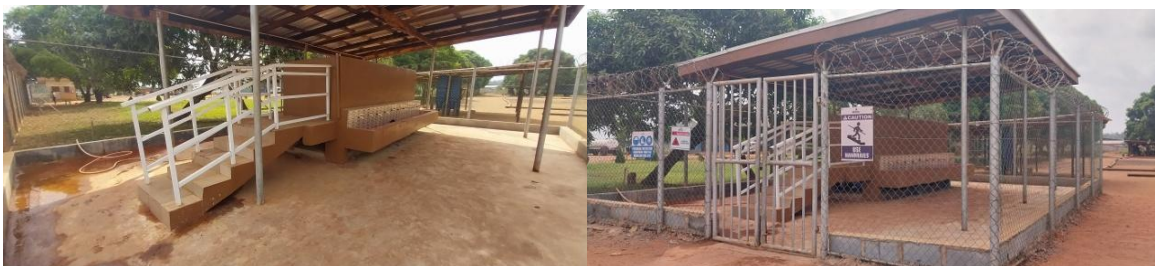
There is a designated point newly constructed for agro-chemical/pesticides mixing purposes. The facility is bunded to contain spills and secure with adequate safety signage installed. Necessary precautions are taken on the issuance and handling of pesticides. All workers involved in the handling and use of pesticides are kitted with appropriate personal protective equipment.

**Plate 2.12: Agrochemical Mixing Point at Rubber Estate**

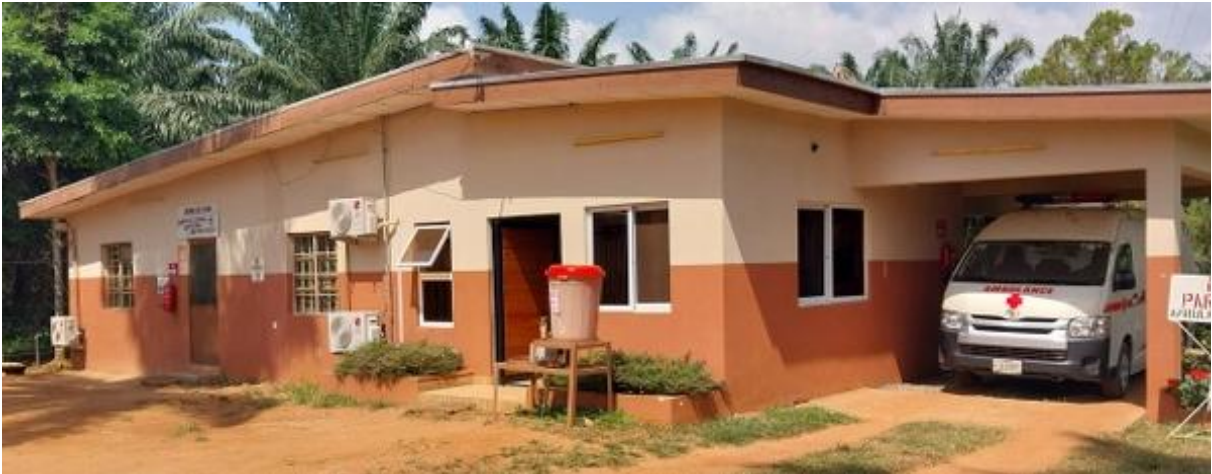
**Plate 2.13: Main Estate Clinic Showing the Standby Ambulance**

The clinic has one (1 No.) ambulance at the main estate on stand-by for emergencies. As at the time of this audit the clinical practices and housekeep was satisfactory.

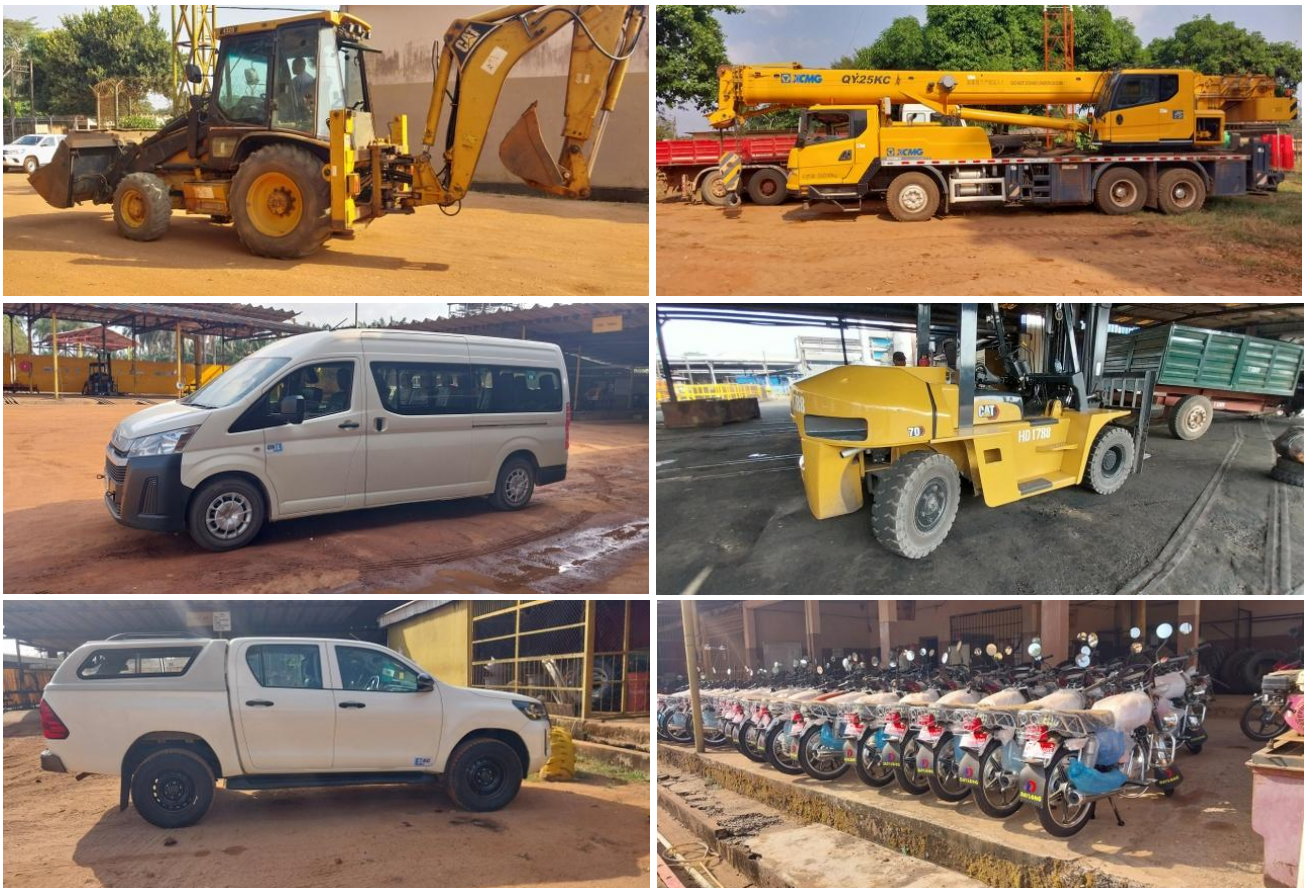
**Plate 2.16: Picture Showing Some Light Vehicles and Heavy-Duty Truck used within the Estate**

Two categories of vehicles are provided for transportation namely light vehicles fleet and heavy-duty fleet. The light vehicles fleet comprises salon cars, 4-Wheel Drive jeeps, and mini-buses. The Administration department controls them. The agric department controls the heavy-duty fleet comprising Lorries, trailers, tractors, and buses.

There are also within the heavy-duty fleet, tippers (7tons and 10tons) and Fixed Bodies. The fixed bodies are long articulated carriers, with capacity of 150 persons, used for mass transportation of workers into and out of the main estate. Lorries with a capacity of about 100 persons are also used to transport workers.

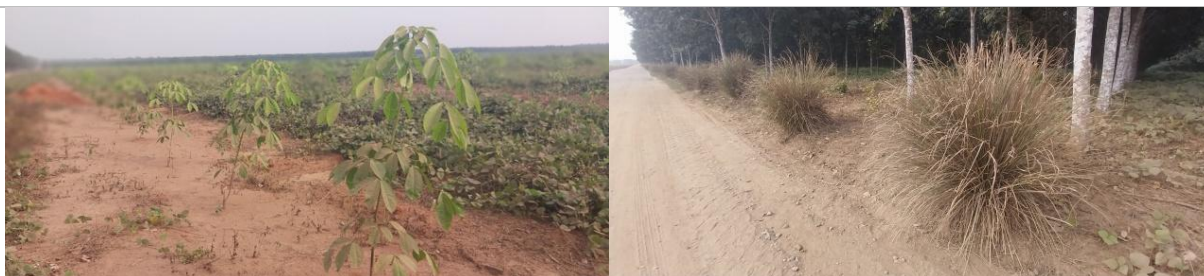
**Plate 3.2: Soil Erosion Control and Enhancement Plants**

| ISSUE | GUIDELINES | CURRENT PRACTICE | REMARKS |
|---|---|---|---|
| | Use cover crops such as, Crotalaria, Canavalia, Mucuna or Tephrosia; intercropping along contours with legumes such as <i>Cajanus</i> , <i>Sesbania</i> , <i>Lupinus</i> , <i>Tritolium</i> , and creating multi species shelterbelts, and/or windbreaks to reduce evapotranspiration and soil loss through water erosion. | Interrow are ploughed and cover crops such as <i>Pueraria plaseoloides</i> and <i>Mucuna bracteata</i> are broadcasted / planted which grow vigorously and form a dense cover over the plantation. In addition, Vetiver ( <i>Chrysopogon zizanioides</i> ) is planted for soil erosion control, soil moisture retention, weed suppression and soil health improvement. | This practice should be sustained |

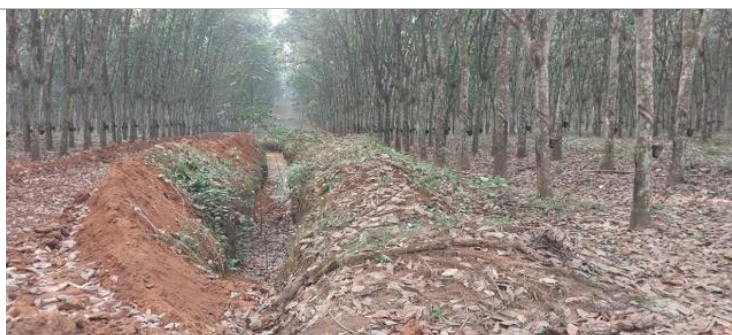
| Use flow control wires and diversion canals to reduce erosion in areas with field drainage | There are some natural drains, and some constructed ones regularly maintained such as side/sedimentation pits. For the control of runoff, especially on the plantation roads, sedimentation pits are dug to reduce runoff and trap sediments in runoff water as could be found across the plantation field as depicted. | No Action Required. |

**Plate 3.3: Sedimentation and/or Side Pit on Roads**

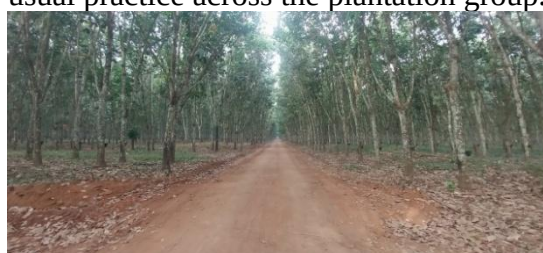
**Plate 3.4: Road Width within the Rubber Estate**

The width of road grading is usually 3m to 10m to avoid erosion and allow for efficient and safe transport. This is the usual practice across the plantation group.

This practice should be sustained

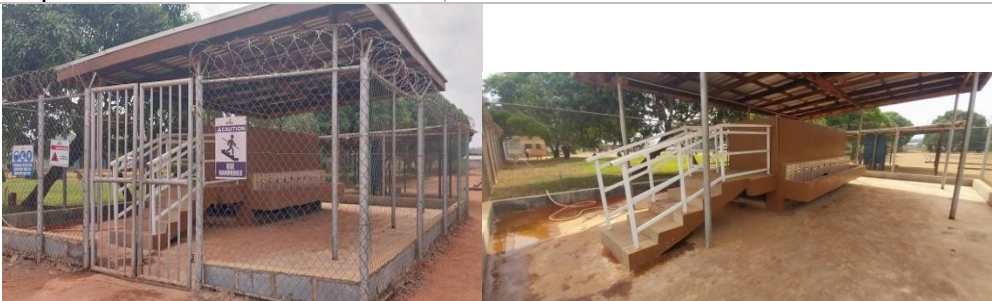
| | Mixing and filling of pesticide tank should be set away from watercourse or drains and if it is on concrete, then water should be collected in a separate sump and disposed as hazardous waste. | Mixing of pesticide is usually done on bunded concrete tank (see plate 3-8 below). | Mixing should be confined to the pesticide tank and this must be done with utmost caution. |
| | <p><b>Plate 3.6: Chemical Pavillion with restricted access</b></p> | | The design should include disposal of wastewater in an absorption trench with more safety signs. |

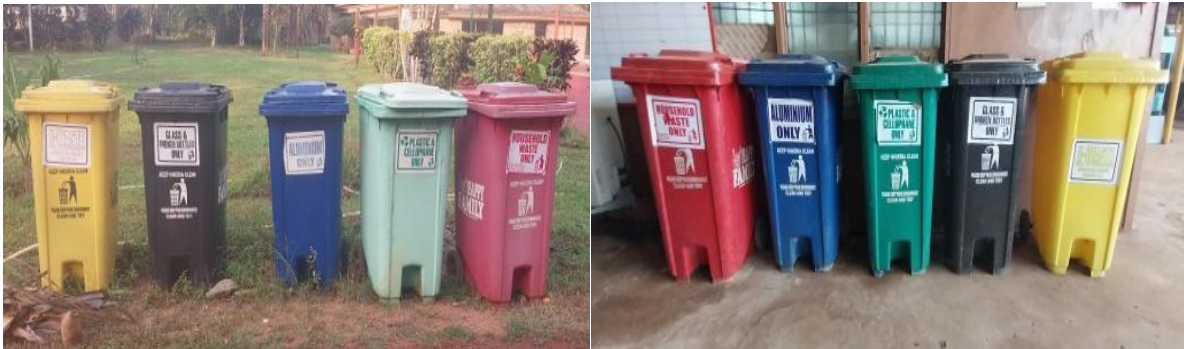
| Issues | Indicator | Current Practice/Status | Comments |
|---|---|---|---|
| Solid Waste Handling | Initiatives to segregate, reducing, reusing, and recycling of waste | <b>Storage:</b> At all the points of waste generation, waste bins/drums are provided for the immediate storage of different solid waste (see Plate 3.8 below).<br><br><b>Collection and Transfer:</b> Containers are located at designated places to collect waste. Wastes from the storage bins and drums are emptied into the waste collection containers, waiting for them to be transferred to the dumpsite.<br><br><b>Disposal:</b> The solid waste collected is transported by means of a tractor and disposed at the solid waste dumpsite. (See plate 3.9). | The current practice of solid waste handling is good but needs improvement.<br><br><b>Red</b> - Household Waste Only<br><b>Green</b> - Plastic & Cellophane only<br><b>Blue</b> - Aluminum Only<br><b>Black</b> - Glass & Broken Bottles Only<br><b>Yellow</b> – E-waste Only |

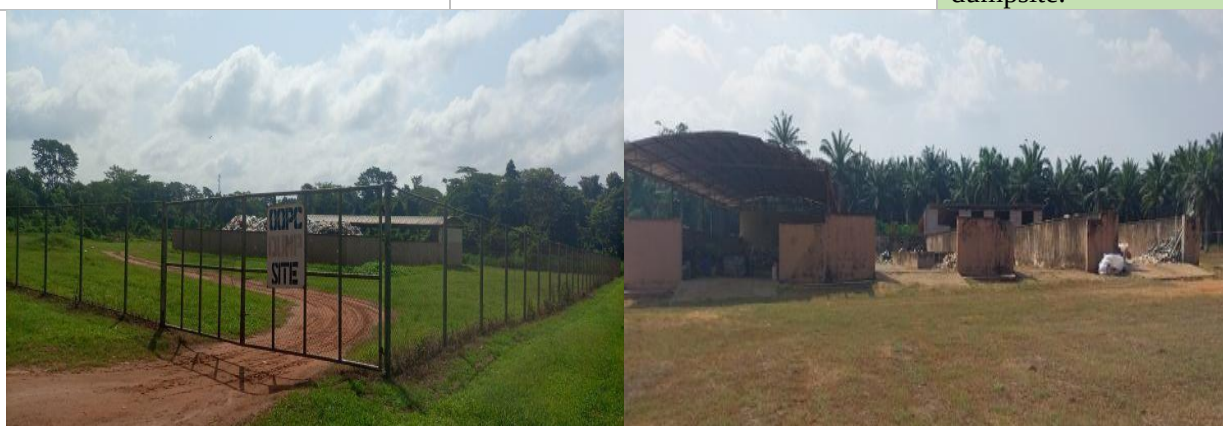
**Plate 3.9: Edo State Ministry of Environment and Sustainability Approved Dumpsite**

| Issues | Indicator | Current Practice/Status | Comments |
|---|---|---|---|
| Waste Disposal | Government Approved Solid Waste Dumpsite | The Company operates an in-house solid waste dumpsite which is compartmentalized for different waste streams including domestic solid waste (see Plate 3.9 below). | The Company has a valid permit from Edo State Ministry of Environment and Sustainability to operate the in-house solid waste dumpsite. |

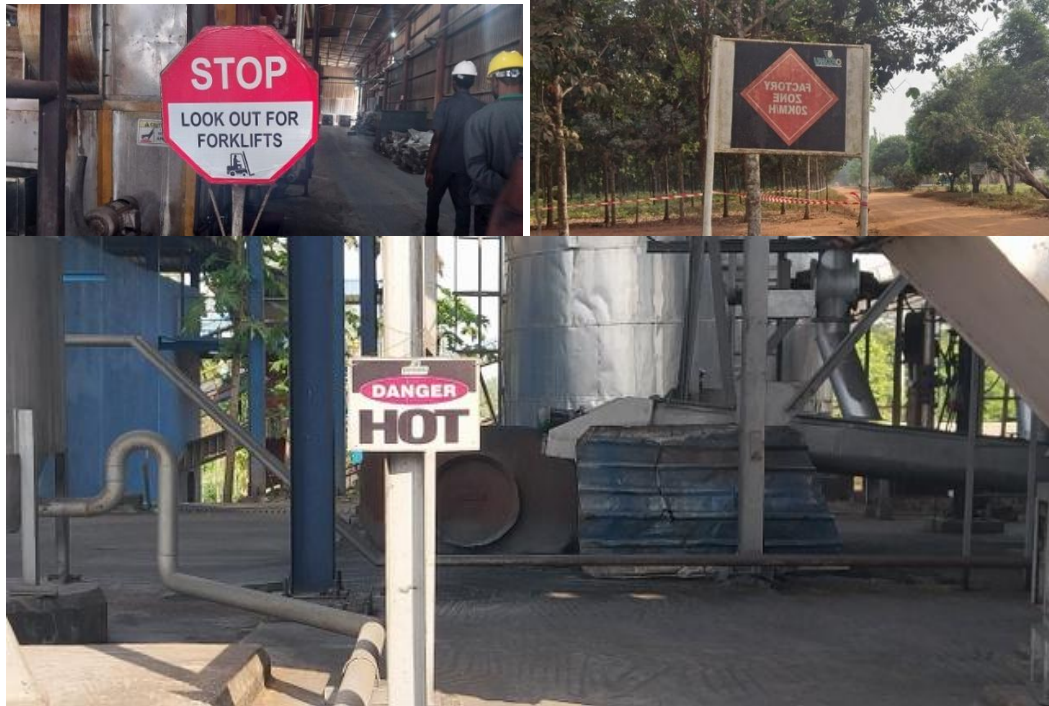
**Plate 3.11: Samples of Safety Signages within the Estate**

| Issues | Indicator | Current Practice/Status | Comments |
|---|---|---|---|
| | Initiatives on Emergency Response Plan for Fire | There is Emergency Response Procedure in place so also is emergency response plan for fire for all facilities (see Appendix C). | This should be sustained |

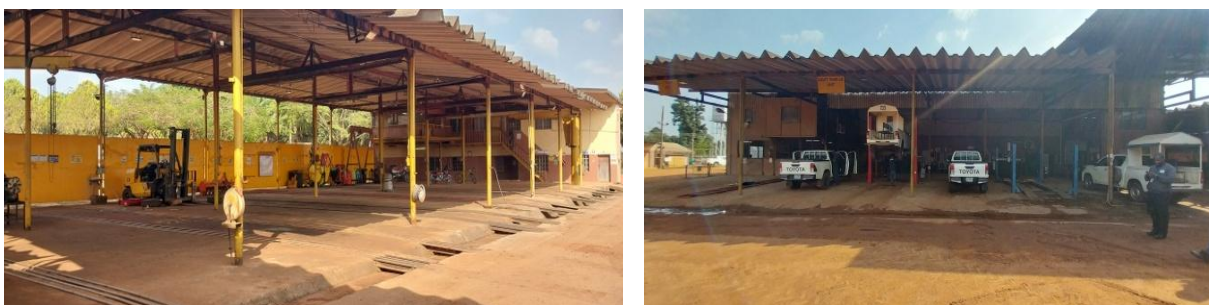
**Plate 4.1: Picture Showing the Facility Workshop**

There is a maintenance workshop, to support the factory operations and located opposite the rubber factory. It comprises different functional units or sections including mechanical, auto-electrical, machine and welding sections. These units undertake factory mechanical works, electrical works, fabrication, and maintenance works. This is in addition to the central workshop located at the main estate comprising different functional units or sections including Lathe Machine, Light vehicle, Tractor, Electrical, Changan, Lorry, Vulcanizer, Mechanical and Welding sections. These units undertake mechanical works, civil repairs, and maintenance works. The workshop is equipped with lifting and hoisting equipment of different capacities between 1.5-5tons.

***Remark: The housekeeping was good, and equipment arranged in a proper way as to allow for easy identification for use.***

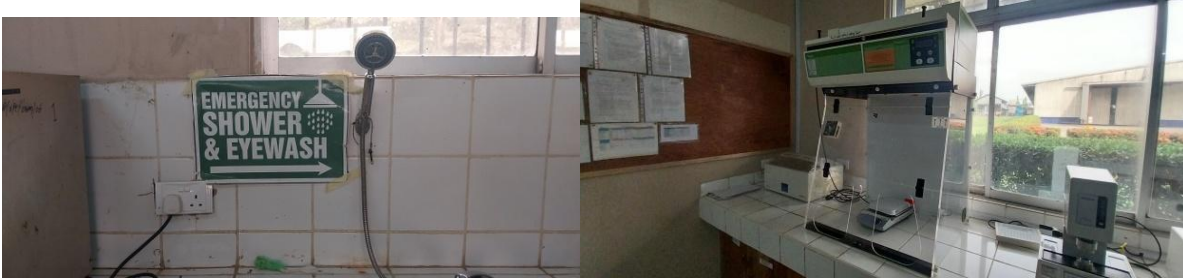
**Plate 4.2: Emergency Shower/Eye Wash and Fume Cupboard**

The rubber laboratory undertakes dirt content analysis, in addition to process and product quality monitoring. It is fitted with equipment including ovens, Wallace rapid plastimeter, roll mill, mooney viscometer, ageing chamber, fume cupboard, scales and balances, and other quality control equipment for process efficiency and quality monitoring. The laboratory is an attachment to the rubber factory administration office located opposite the warehouse loading bay.

*Remark: Adequate safety provisions are in place, Safety Data Sheet are displayed in the laboratory, while chemicals for analysis are requested based on need. There is also provision for an emergency shower/eye wash section. The house keeping is very good at the laboratory.*

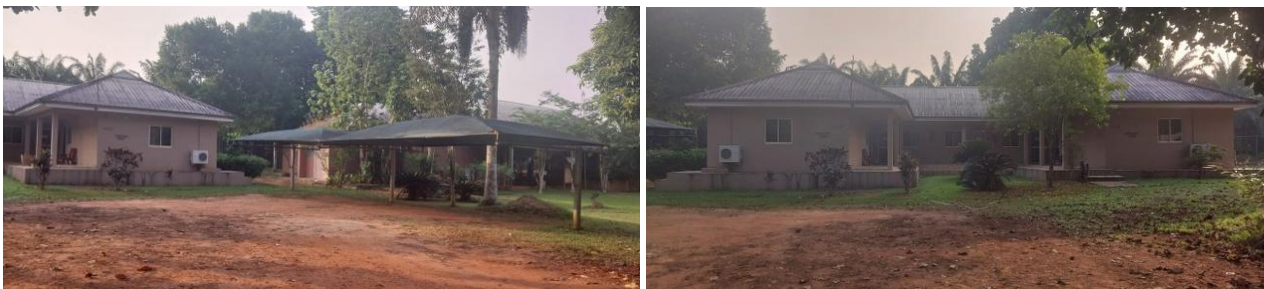
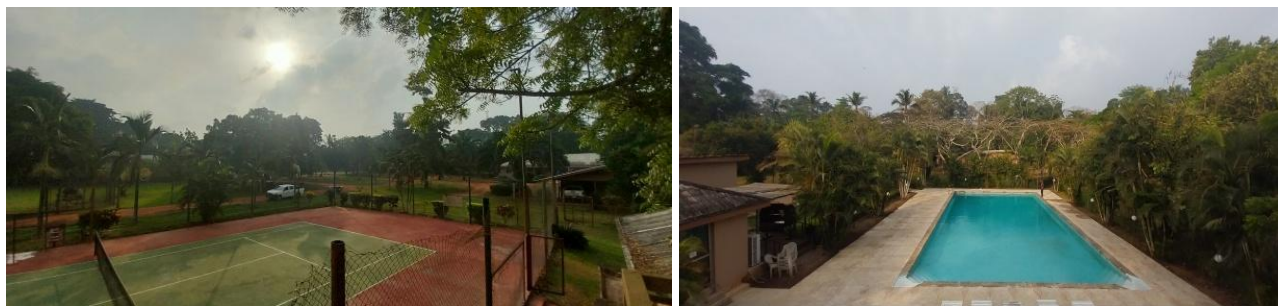
**Plate 4.3: Guesthouse Facilities**

*Remark: The housekeeping is good; safety and waste management measures are put in place and measures to ensure continuous improvement in guest comfort is also in place through the provision of a “suggestion box”. Emergency call lines are strategically placed in the guest house.*

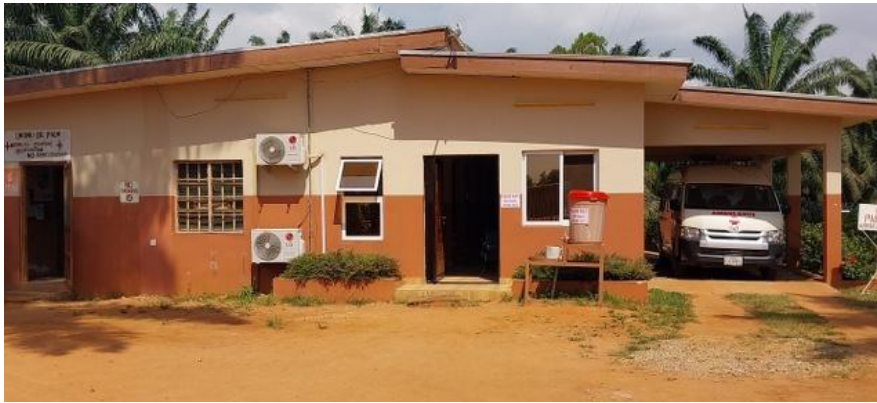
**Plate 4.3: Main Estate Clinic Showing the Standby Ambulance**

The clinic has one (1 No.) ambulance at the main estate on stand-by for emergencies. As at the time of this audit the clinical practices and housekeep was satisfactory.

*Remark: At the clinic, drugs are properly stored including those that needs to be kept at a certain temperature. The general housekeeping and coordination is good and administration procedures are seamless.*

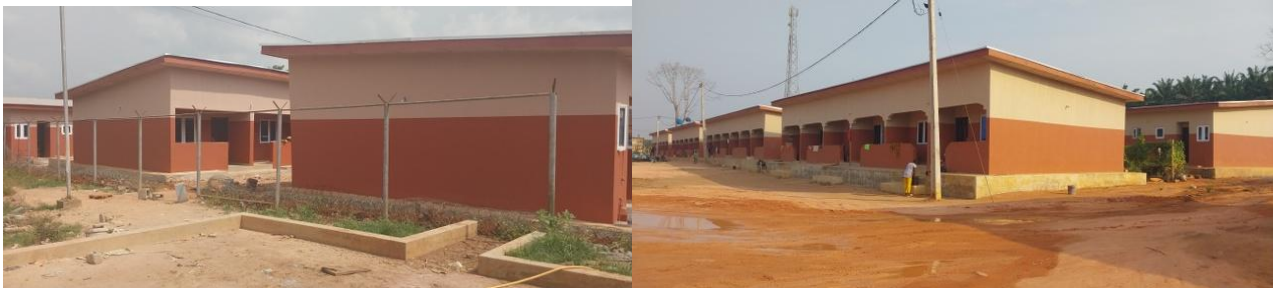
**Plate 4.4a: Some Newly Constructed Buildings at the estate**

*Remark: As at audit time, additional buildings are being constructed while old ones are undergoing renovations. The buildings are constructed with environmentally friendly and good quality materials to achieve maximum comfort for workers and guests.*

*This is commendable, however at the rubber quarters, there are several broken water pipes and controls that need to be replaced. The inspection chamber of the overhead water storage tank point bordering the rubber agric office appears to be caving in. Repair or reinforcement is recommended.*

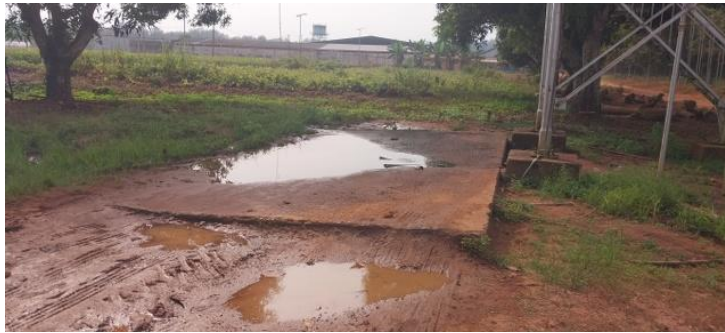
**Plate 4.4b: Caved in Inspection Chamber**

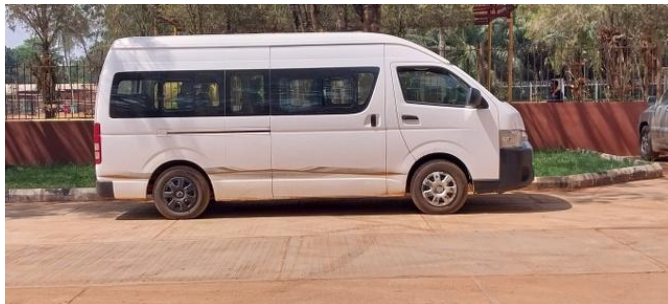
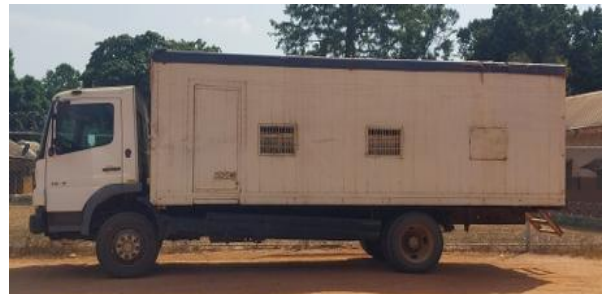
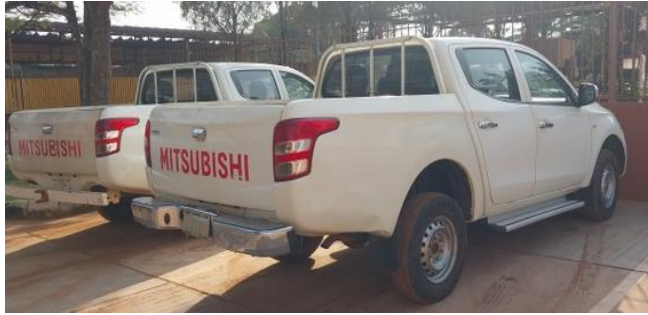
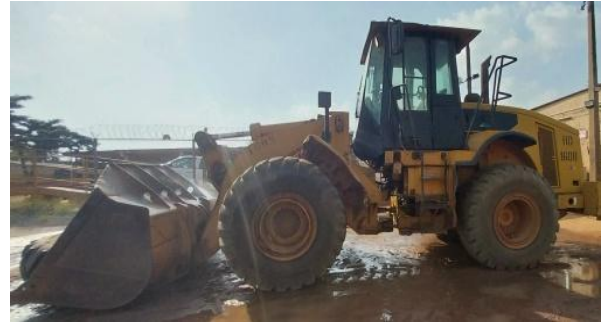
**Plate 4.5: Picture Showing Some Light Vehicles and Heavy-Duty Truck used within the Estate**

Two categories of vehicles are provided for transportation, namely light vehicles fleet and heavy-duty fleet. The light vehicles fleet comprise salon cars, 4-Wheel Drive jeeps, and mini-buses. The Administration department controls them. The agric department controls the heavy-duty fleet comprising Lorries, trailers, tractors, and buses.

There are also within the heavy-duty fleet, tippers (7tons and 10tons) and Fixed Bodies. The fixed bodies are long articulated carriers, with a capacity of 150 persons, used for mass transportation of workers into and out of the main estate. Lorries with capacity of about 100 persons are also used to transport workers.

***Remark: Place oil retention trays under parked trucks to prevent oil drips from polluting the soil.***

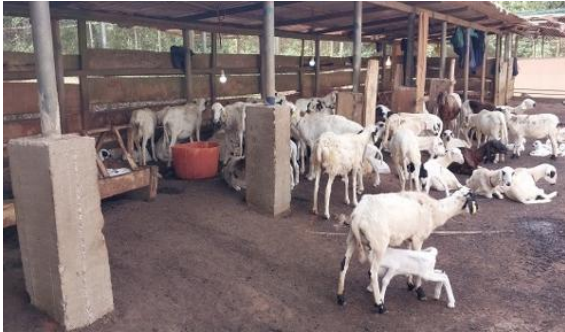
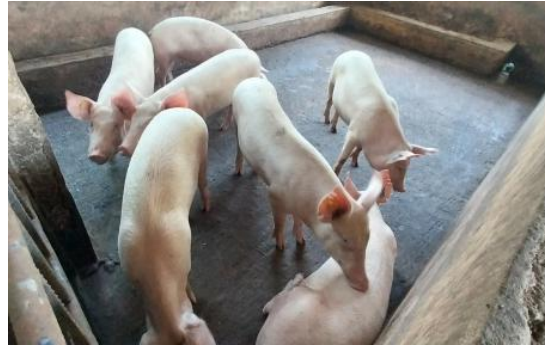
**Plate 4.7: Picture Showing Animals at the Pen within the Estate**

ruminant animals including cattle, sheep, goats and pigs. The pens are very well confined with chain-link fence wire and controlled entry is observed with a disinfection process done by visitors to reduce the risk of stock contamination. New stocks are usually quarantined for two months before the introduction to the larger stocks. There are two (2) veterinary doctors attached to the livestock pen.

***Remark: There is inadequate signage at the facility especially at the entry where disinfection of visitor's boots, or footwear takes place.***

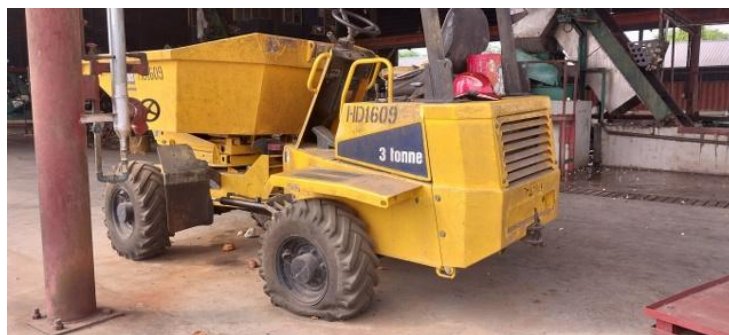
**Plate 4.8: Broken Down Rubber Cup Lump Bucket Conveyor (HD 1609)**

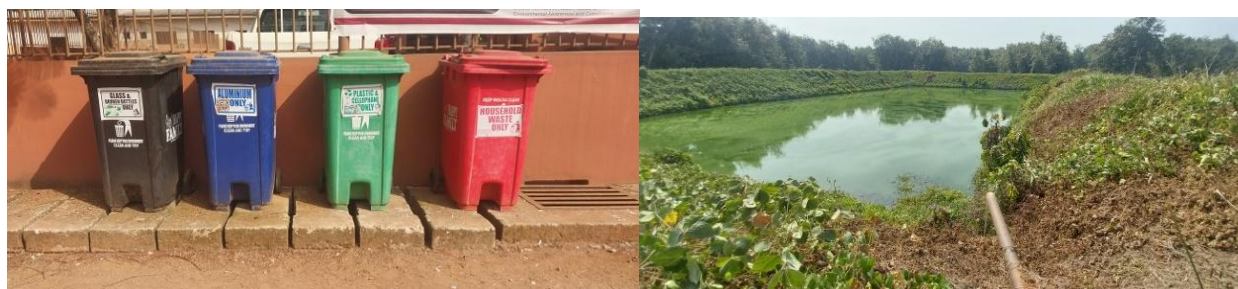
**Plate 4.9: Color Coded Bins and Effluent Serial Pond at the Rubber Estate**
